Nepal Health Sector Support Programme III (NHSSP – III)

Joint Hospital Assessment Report – Karnali Province

Dolpa Hospital, Dunai, Dolpa District

27 August 2019

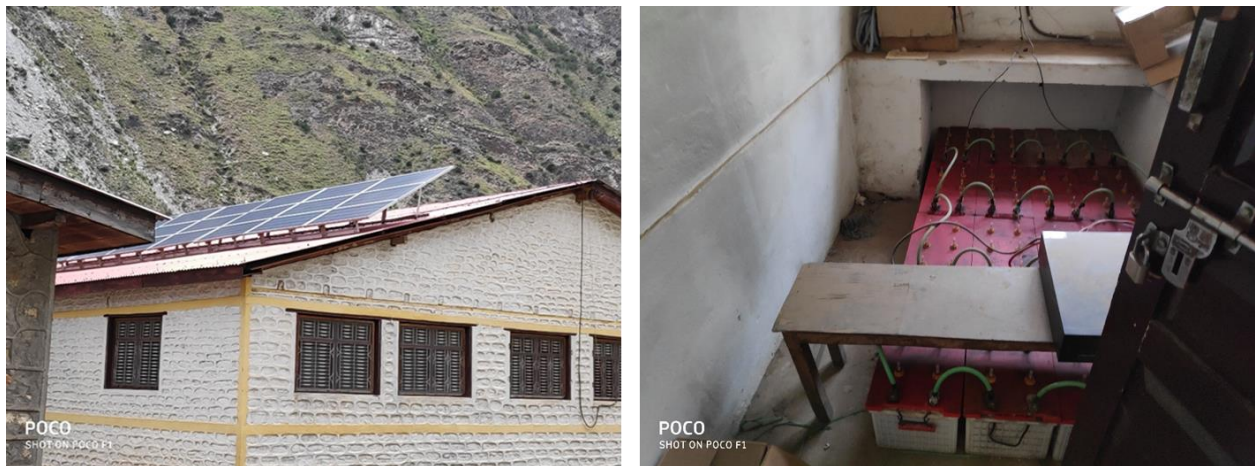
- Hospital has 3-phase electricity supply but lacks dedicated supply and transformer
- It has a generator in working condition
- There is a solar power back-up system of approximately 4 KW output but this is not in working condition (see Figure 3). It appears that the system is over 5 years old.

Figure 3 (left) Solar Panel on BEOC building (right) Solar Power Battery (not working) inside the BEOC building

- Repair/maintenance/ replacement of the solar power back-up system
- Repair and maintenance of the residential quarters
- Construction of proper surface drainage

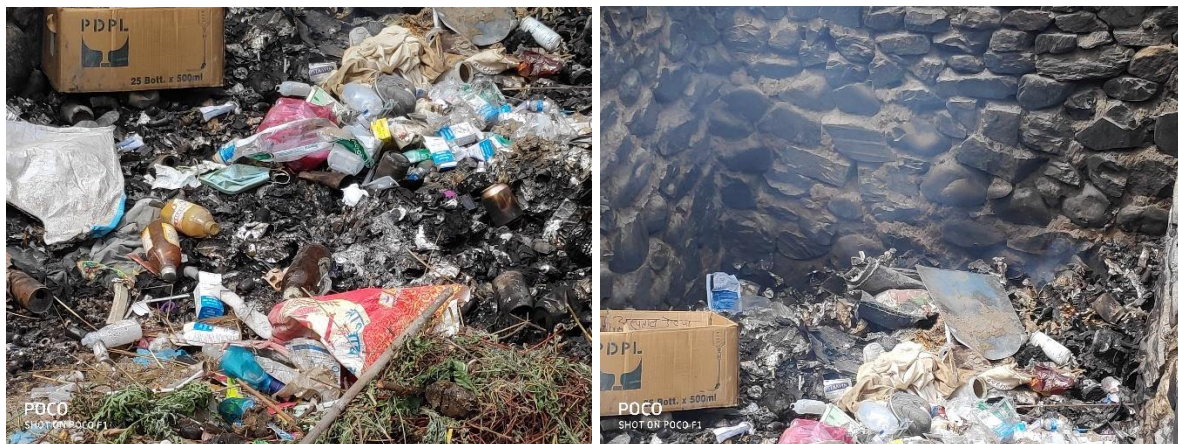
The hospital uses the pit disposal method. There is no autoclave. The majority of wastes are burned out in the open, and the burning of plastics was observed, contravening health standards (see Figure 4). It has also been observed that there was no segregation of the wastes.

Figure 4 (left) Open waste and (right) open burning of unsegregated waste

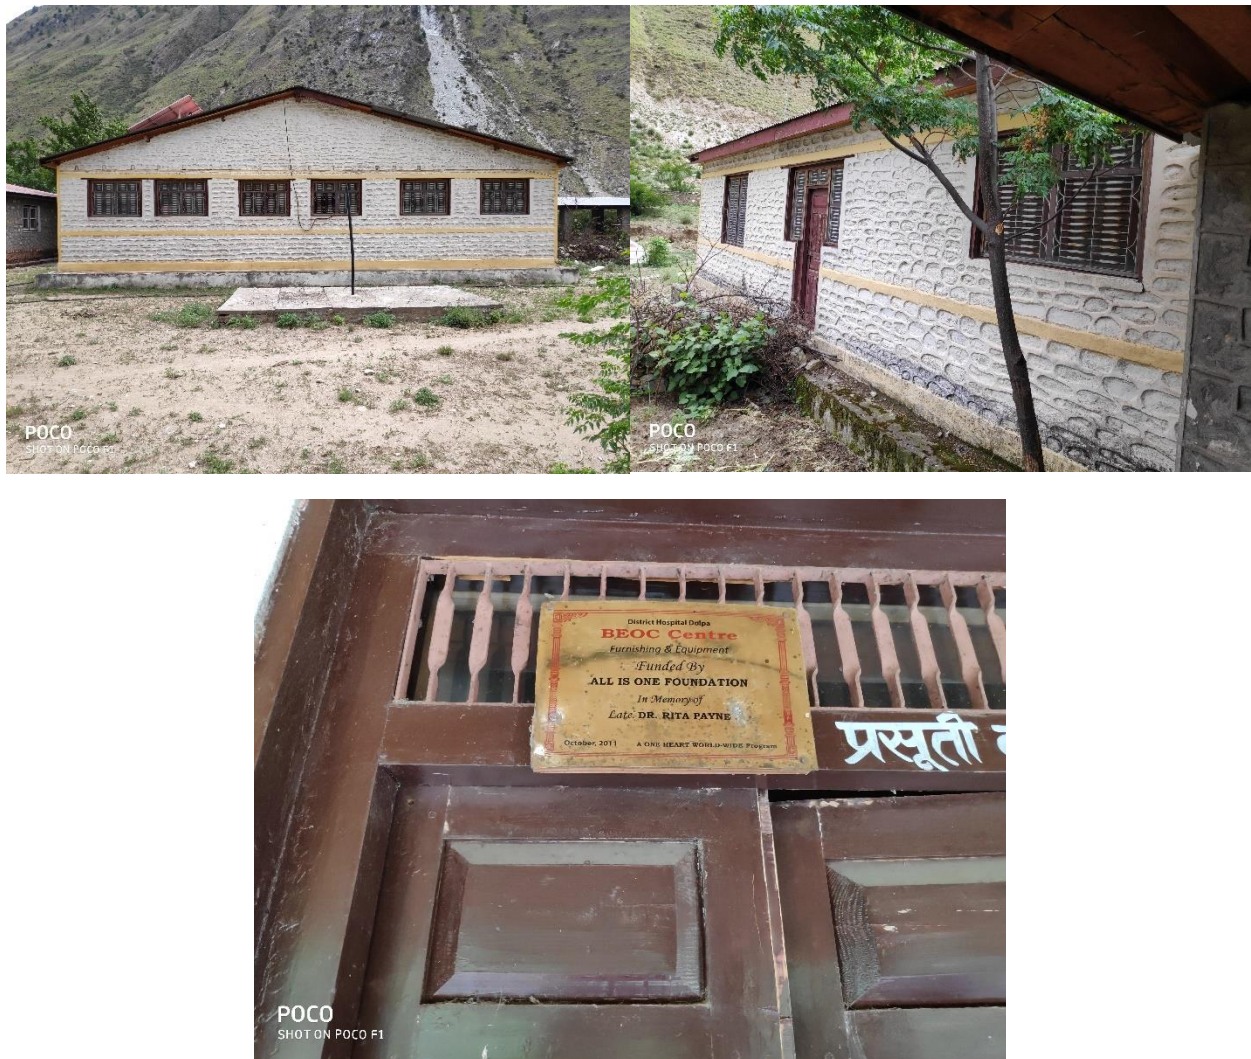
The BEOC block was built in 2065 BS (2007) using the standard type design (see Figure 5). However, it is used currently only for deliveries, while the sluice and other spaces are not used for the purposes they were designed for. This may be because the hospital management was never given or less effort in an orientation on the plan, design, and functions of the buildings during and after its construction. Neo-natal related services are not provided.

Figure 5: views of the BEOC Block

Management and staff should be given a re-orientation and briefing on the layout, functions, and operations of the different buildings to ensure effective planning and operational use.

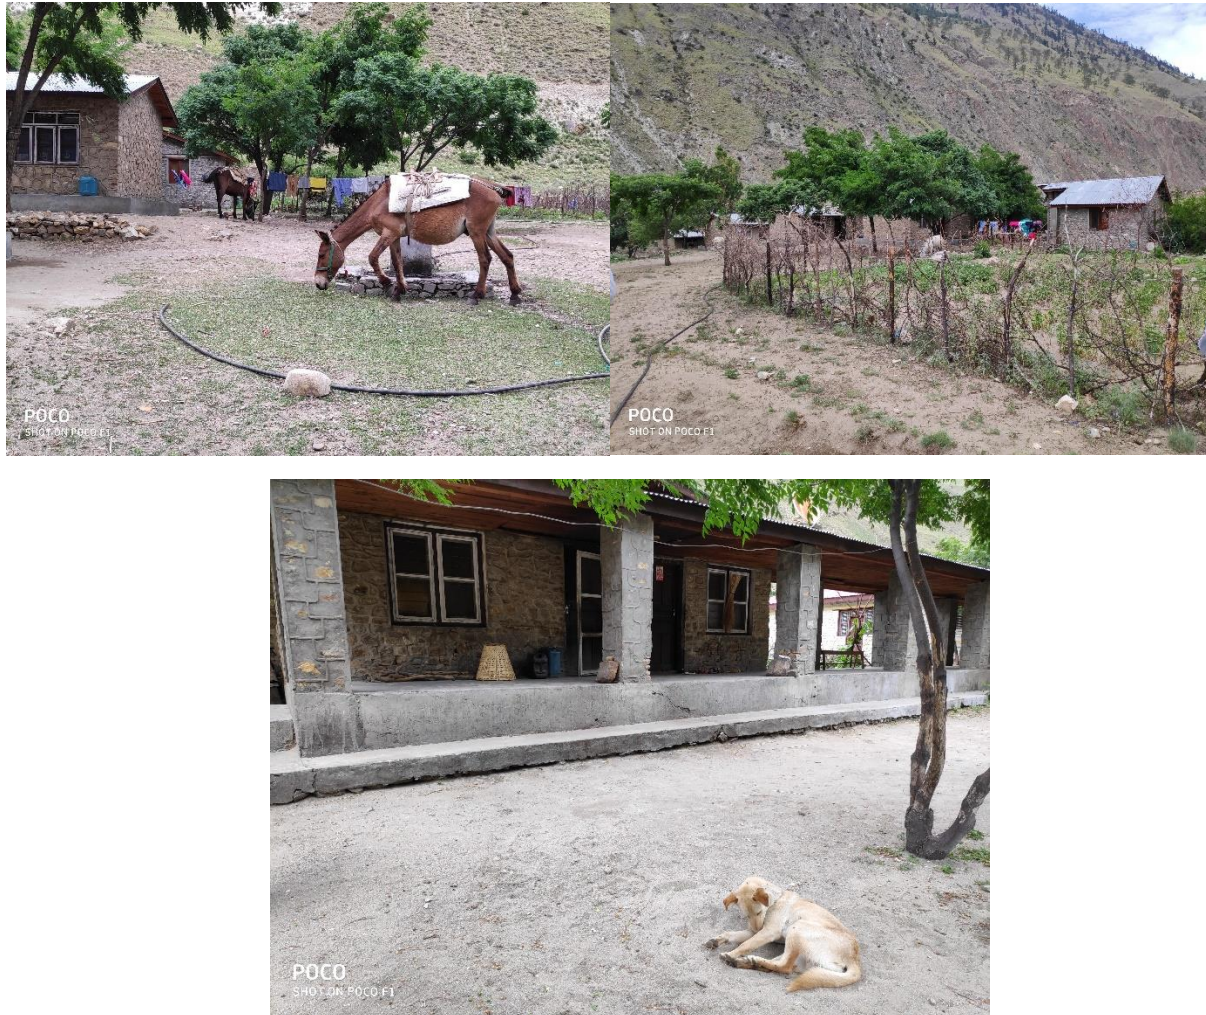
There is no proper boundary wall to the north of the precinct. This enables animals and people to trespass onto the hospital premises. (see Figure 6). It also opens hospital land up to the risk of encroachment from outside.

Figure 6: Open boundary of hospital and animals on site

- Construction of new mortuary block
- Provision of semi-permanent fencing to precinct boundary
- Repair and maintenance of the water source and intake
- Construction of overhead (50 K liter) and underground (1 lakh liter) water tanks

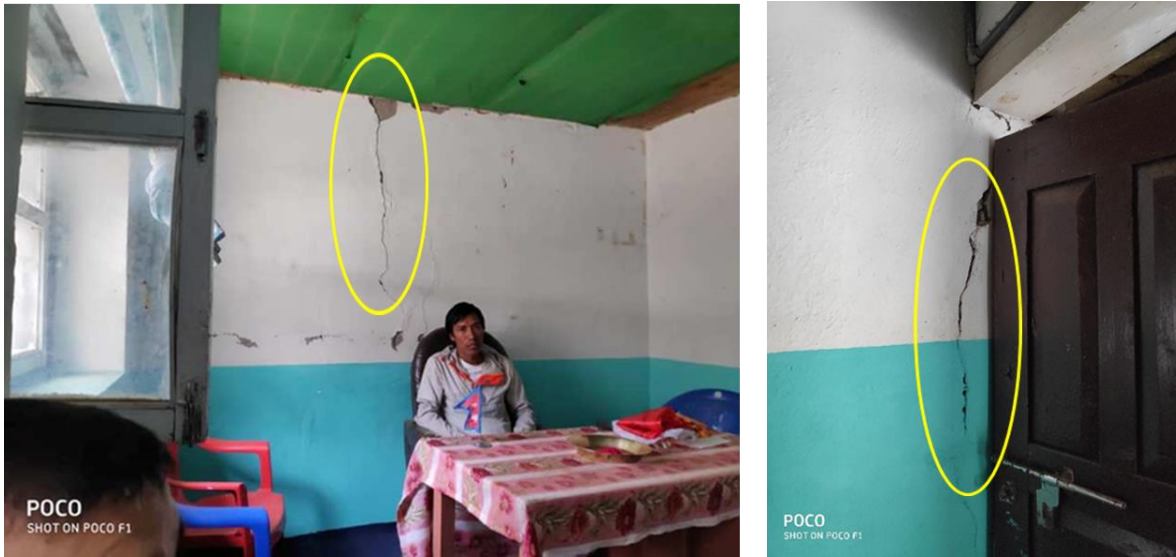
Wall cracks were observed in most of the buildings, including the main building (see Figure 7). In the residential quarters their walls with cracks to both sides (see Figure 8). Cracks to corner joints, window and door spaces are often the result of seismic activity. Other cracks can be due to settlement and unequal load bearing.

Figure 7: Cracks in the main building

The cracks, settlement, and foundations at the left/north side of the buildings should be given a detailed damage assessment, and appropriate repairs made.

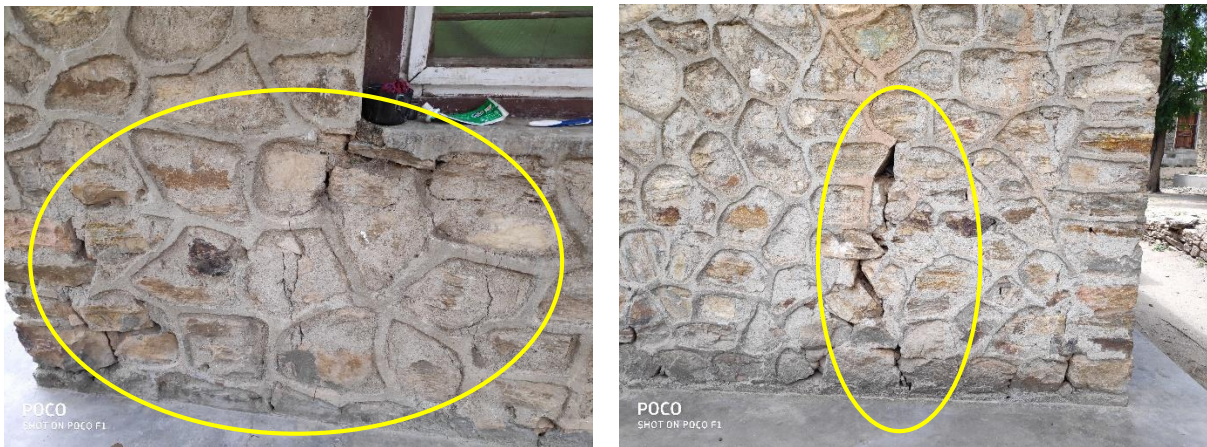
Relatively, the quarter buildings consist of more cracks on both sides of the wall. It was visually observed on the outer wall of the quarter (see figure 8).

Figure 8: Cracks on the outer wall of the quarter

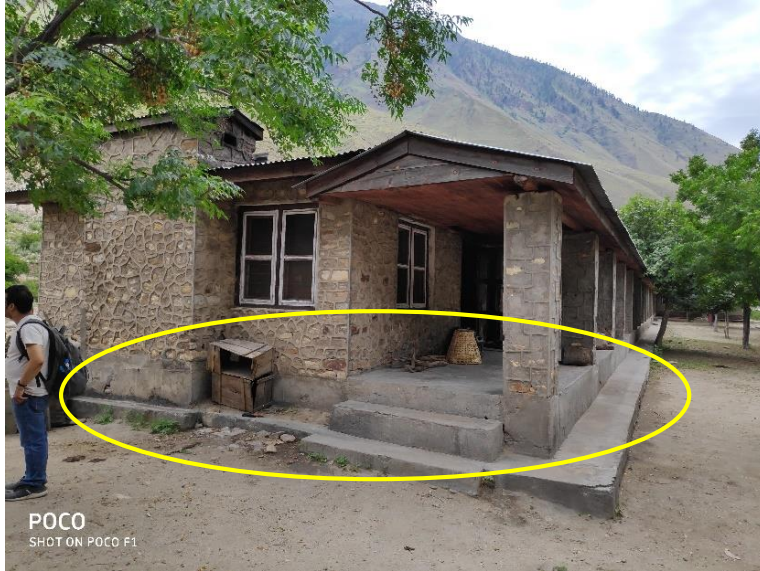
The buildings on the site are in general poorly maintained – there are various examples of deterioration, including crumbling mortar and stonework, and spalling concrete (see Figure 9).

Figure 9: Lack of maintenance to stone and concrete elements

Visible deterioration of the building fabric – particularly seismic bands and cracks - should be repaired. CGI Roofing should be replaced, should properly be anchored, should have rainwater harvesting mechanism and should ensure on regular cleaning. Hospital management should initiate a regular cycle of building maintenance through the preparation and implementation of maintenance plans.

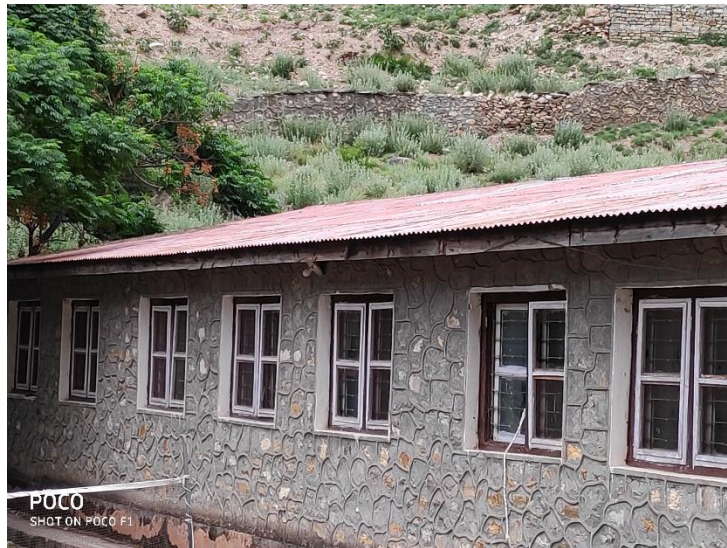
Various blocks lack components that would improve seismic strength and resilience, notably a lack of sills and lintels on windows and doors (see Figure 10).

Figure 10: Building without seismic resilient elements - sills and lintels – at the windows

- Seismic retrofitting of buildings where required
- Demolition of the most vulnerable buildings and decanting space construction to support retrofitting process
- Landscaping architectural elements
- Permanent compound wall
- Improved gate and accessibility from the road (aligned with road upgrading)
- Provision of dedicated medical oxygen plant

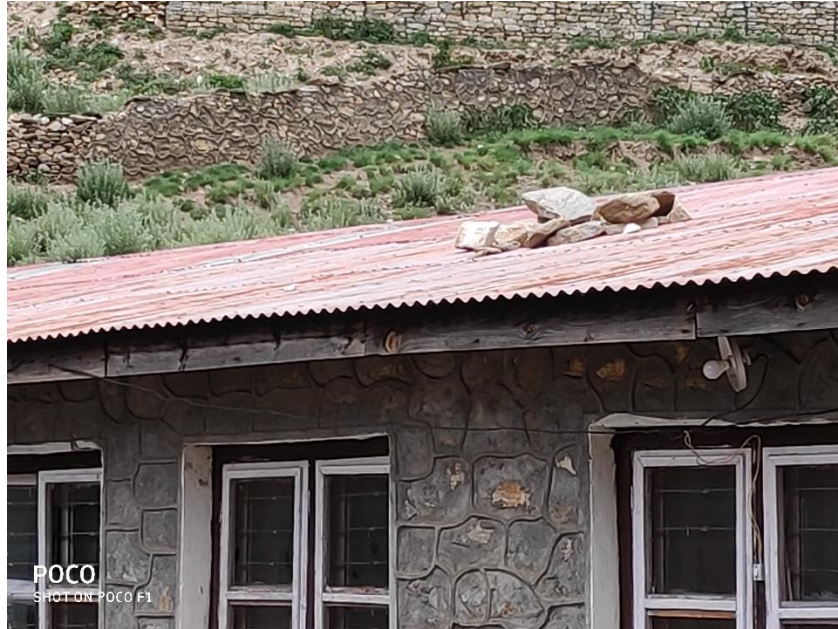
The NHSSP team noted various cases of loose and lifted CGI roofing sheets, due to weak fixings and poor maintenance. Rotten sheets will need replacing. Given the local climate and high winds, it is important that that the CGI roofs are anchored securely (see Figure 11).

Figure 11: CGI roofing needs replacement and proper anchorage

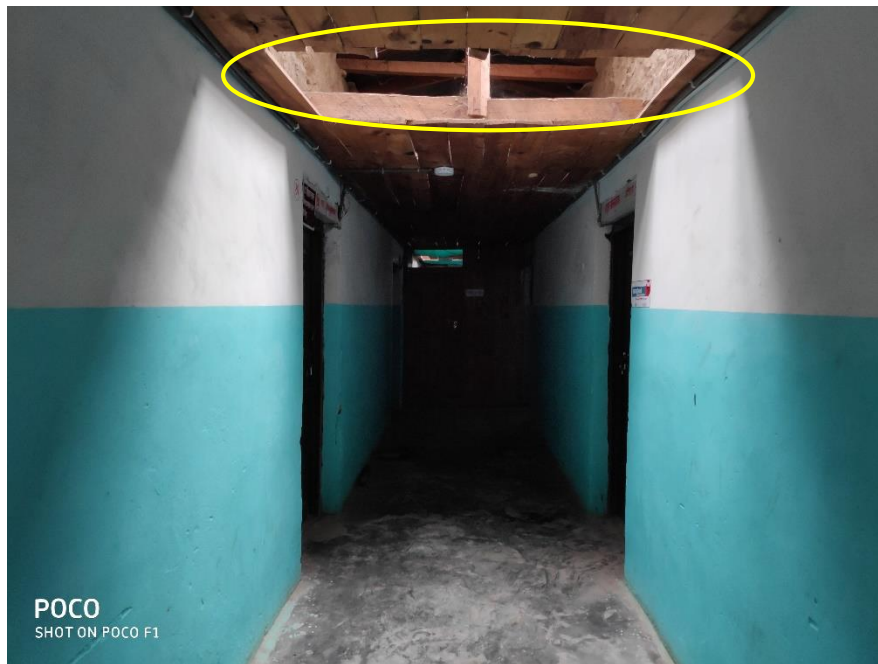
The main hospital building has a story height of 3m – the upper meter of this consists of unreinforced masonry, which is not properly anchored and restrained. This will create an unbalanced load path in the wall during a seismic event, which the possibility of buckling and collapse (see Figure 12).

Figure 12. Unreinforced masonry wall above the false ceiling

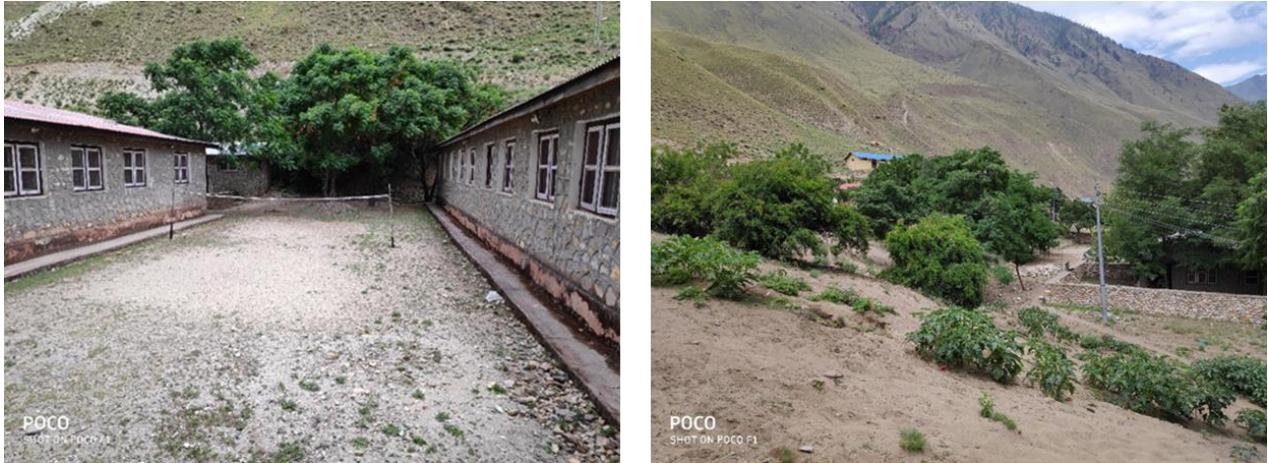
The hospital site slopes from north to south, and there is no surface drainage system for rain and stormwater. Ground surfaces are not well maintained. There are no gutters on buildings, and so no provision for rainwater harvesting. (See Figure 13)

Figure 13. The poor drainage system and unmanaged landscaping at the rear of the hospital precinct

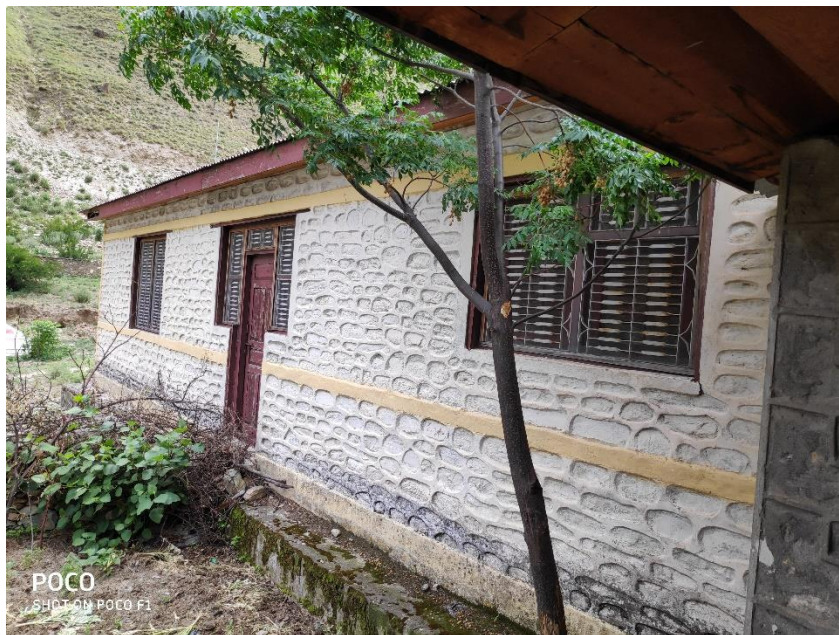
There is no heating system nor heating, ventilation, and air-conditioning (HVAC) units in critical care areas and the in-patient area. This is especially problematic in areas used for mother-child cases (see Figure 14).

Figure 14. BEOC building without HVAC (Photo from rear of the hospital)

The Critical Care and In-patient areas (especially for mother-child cases) should be provided with the heating system. Similarly, HVAC services should be in place in critical areas like emergency and proposed OT block.

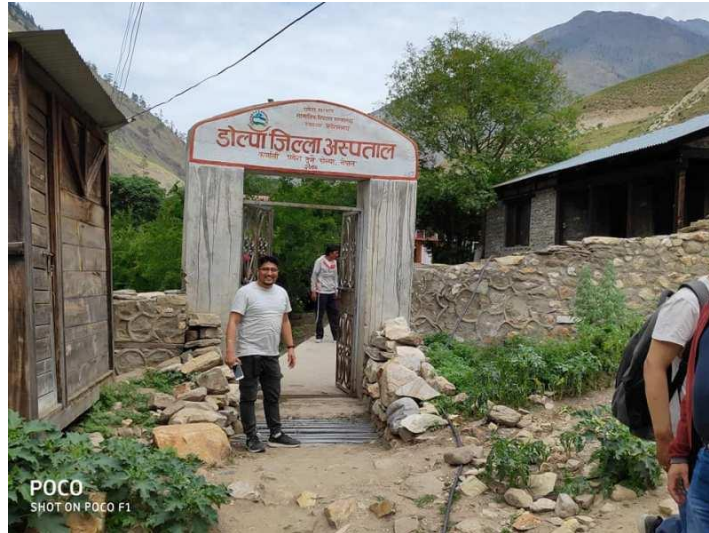
There is a narrow entry gate in the hospital, which is pedestrian access only. Even this would hamper access for patients on stretchers (see Figures 15 and 16)

Figure 15: Narrow entry gate to the hospital

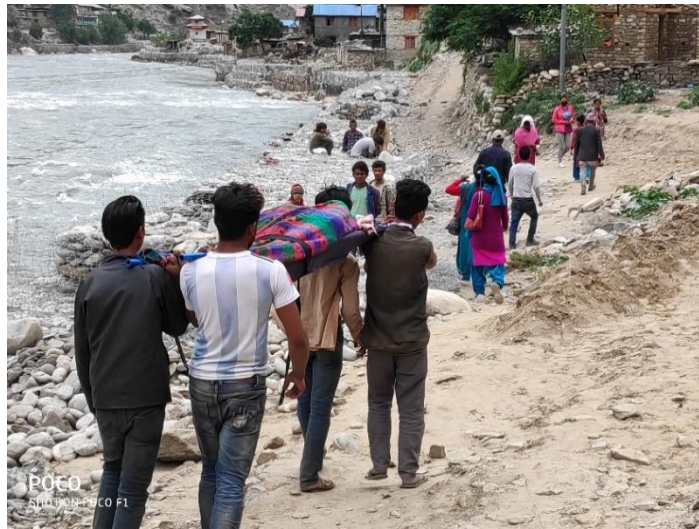
Figure 16: Stretcher patient being carried to the hospital

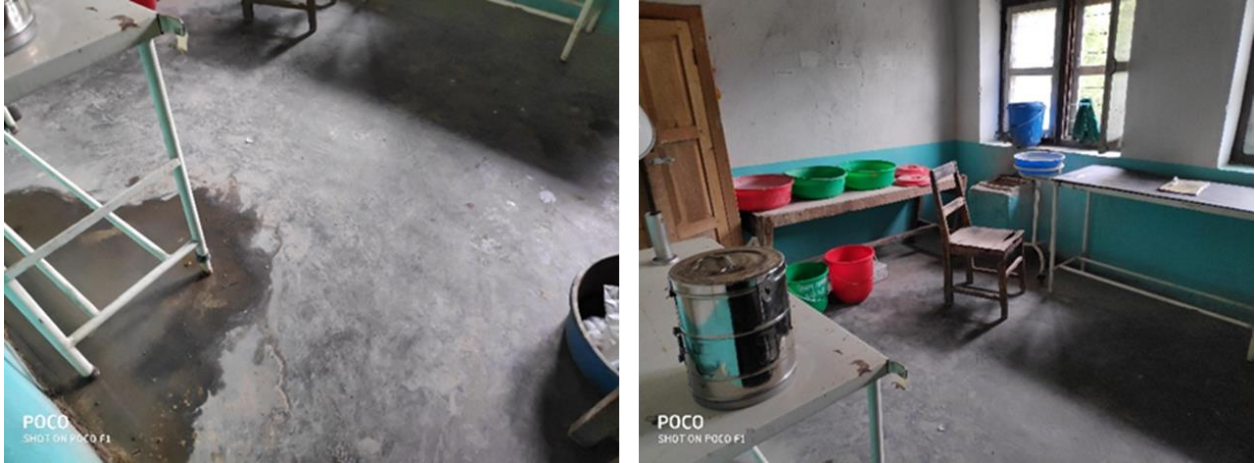
Almost all floors inside the buildings were in poor condition. The covered pathways have relatively better floor surfaces than those inside (see Figures 17 and 18).

Figure 17: Interior floor finishes in poor condition

Internal floors should be repaired and/or refurbished as necessary. In critical service areas, the anti-bacterial flooring and interior walls with anti-bacterial paint including the sterilise indoor environment should be provided as of current standards

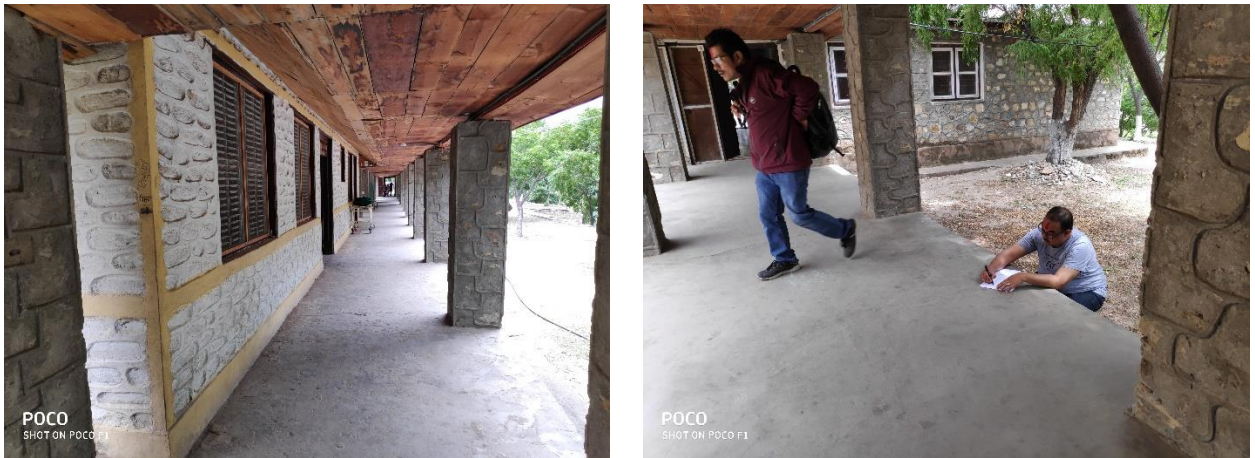
Figure 18: Exterior walkway floor surface

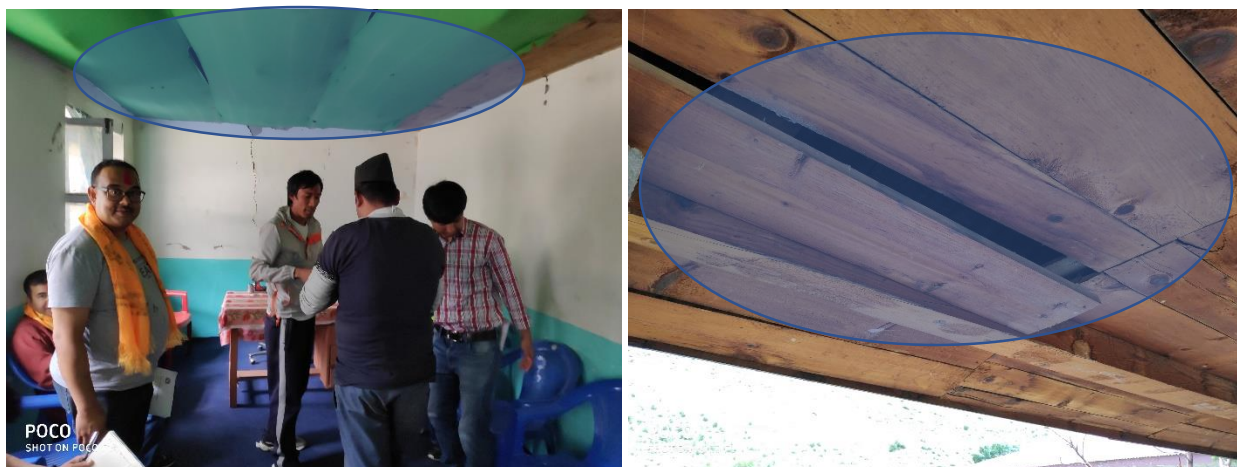
The NHSSP team found that the false ceiling of the main building was made from wooden boards. In some cases, these had deteriorated to the point of requiring replacement, while other sections could be repaired. Roof trusses were checked and need repair work (see Figure 19).

Figure 19: False ceilings requiring repair or replacement

Repairs have to be made to the false ceilings, and areas that cannot be saved should be replaced.
