Nepal Health Sector Support Programme III (NHSSP – III)

Rukum Primary Hospital
Joint Hospital Assessment Report – Karnali Province
Final Draft
26 August 2019

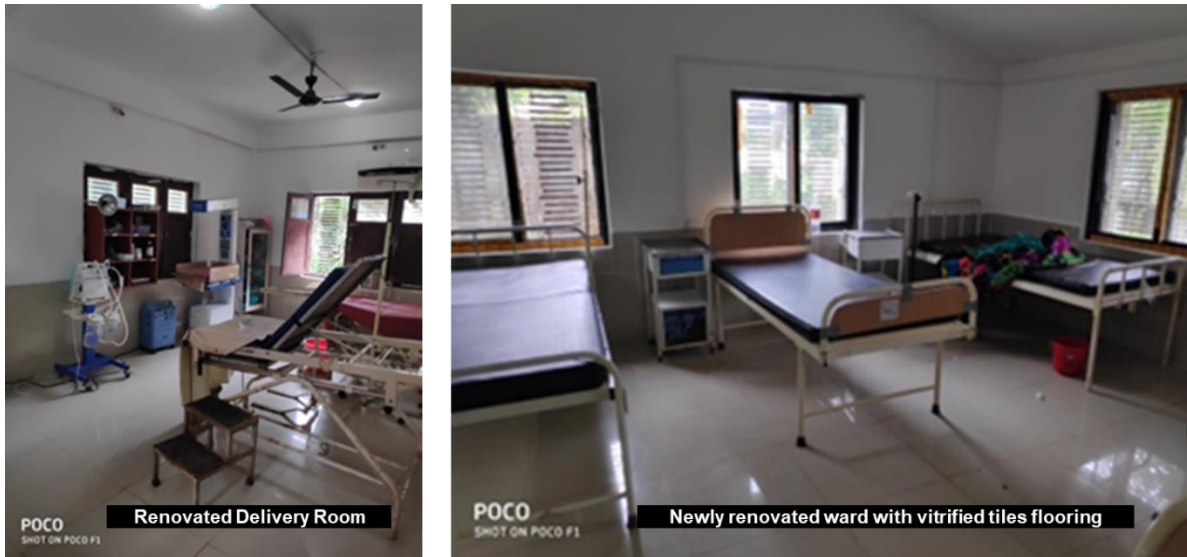
Figure 4: Renovations and floor improvements

plaster on the inside walls while the outside wall surface is painted. The CGI roof sheets on most of the buildings were replaced recently. In addition, the cement flooring punning (skim coating) has been replaced by vitrified tiles in all service blocks apart from the Hospital Administration building (see Figure 4).

- Change the floors of the administrative areas and also of the open covered spaces outside Lab block and other blocks
- Replace the current OT scrub with a standards-compliant version. Replace the false ceiling and lighting fixtures of the OT, and treat the OT area with anti-bacterial paint.

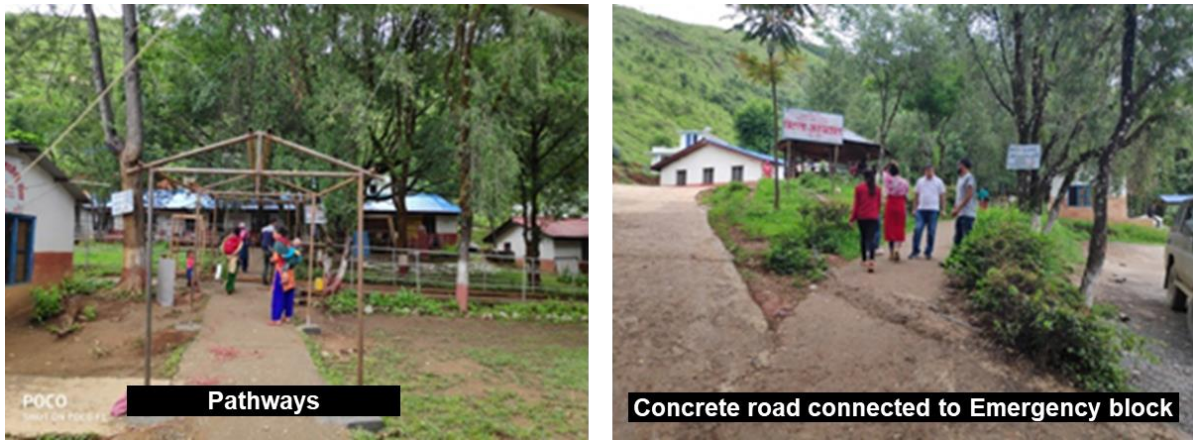
Figure 5: Pathways and accessibility

The Hospital has good road connections. The Emergency unit is accessible to the ambulance with a concrete road laid inside the precinct. The porch above the ambulance parking area (to protect patient transfers in bad weather) is missing. All other blocks housing hospital services are connected by pathways and natural sloping ramps making it accessible for disabled people and trolleys. The pathways have metal bars on both sides which fence off the pathways from the open space – these can act as handrails but actually are too thin to serve as grab bars to support elderly people and people with disabilities (see Figure 5).

- Proper fencing of the Hospital facility is very important including the installation of security systems such as CCTV cameras and intercom system.
- Pathways need to be upgraded and expanded to all the service areas. Curbstones should be fitted to prevent soil being washed onto pathways. Suitable bars and handrails should be fixed along the pathways to improve accessibility and mobility for the elderly and disabled. The installation of covers to the pathways should be completed, as well as the installation of lights and pathfinders. A porch roof should be to the Emergency block access. There should be the installation of ramps/removal of obstructions to make all the blocks accessible to wheelchairs and trolleys.

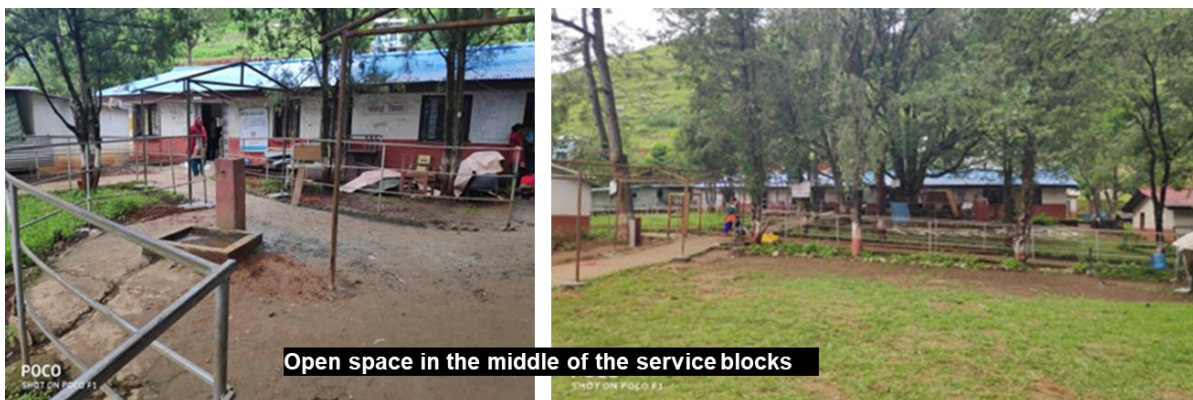
Figure 6: Public open space and muddy ground

The pathways linking the services are not covered throughout making it difficult to walk around during rainy seasons to both the service providers and hospital users. Mud is washed onto the paths from adjacent open areas making them slippery and unsafe. The NHSSP team was informed that a limited budget was available to cover some pathways, using CGI sheets on the truss frame.

Also, the open earthen space in the middle of the precinct is used by the visitor as a waiting and interaction space. In wet seasons mud from this area is tracked onto pathways and floors in the hospital service areas (see Figure 6)

- Improve the landscaping and increase the number and size of waiting areas
- Immediately install a proper canteen with Kitchen for patients, replacing the existing temporary CGI shed.

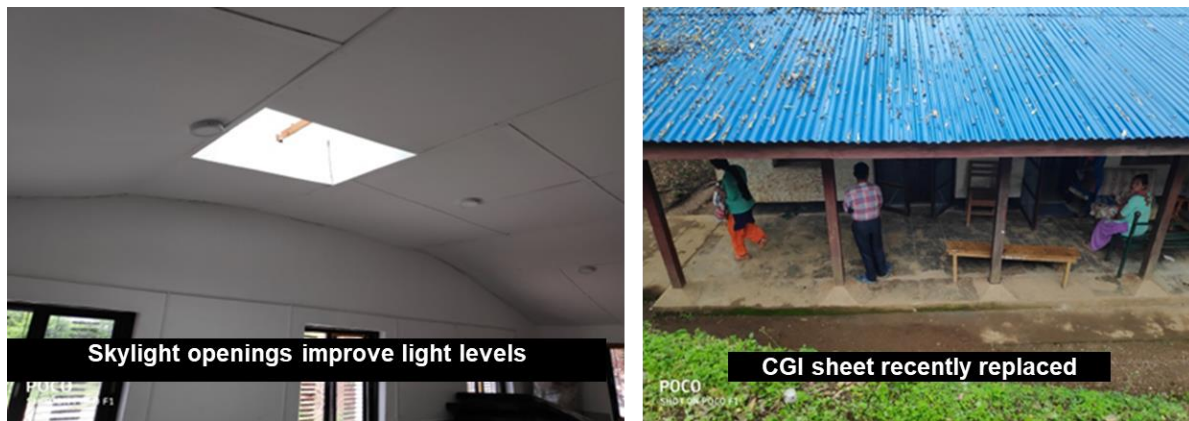
Figure 7: Roof refurbishment

All the service building blocks, including the administration building, have recently been re-roofed. Although roofing sheets have been replaced, the wooden false ceiling below the overhang of the roofs remains in situ. The roofs have no rain gutters or downpipes. In some buildings, natural light has been improved through the use of skylights and transparent sheets (see Figure 7). This refurbishment has been a good initiative by the Hospital authorities.

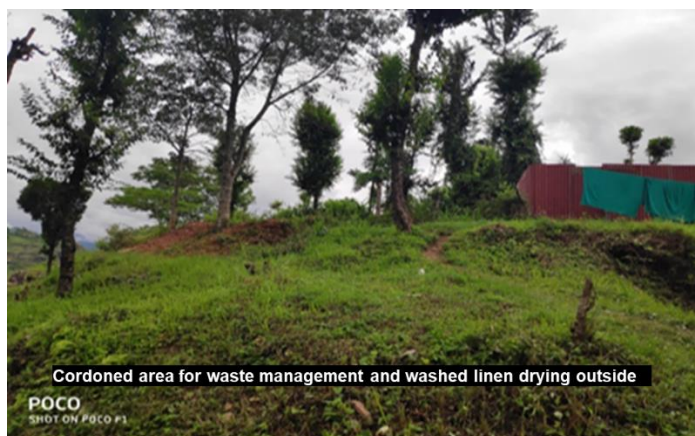
Figure 10: Cordoned waste management area

The waste management area was properly cordoned and appeared to be well-managed. However, without investment in plant for waste treatment, the facility may take strain when the Hospital expands its capacity (see Figure 10). There is a placenta pit for the safe disposal of the placenta.

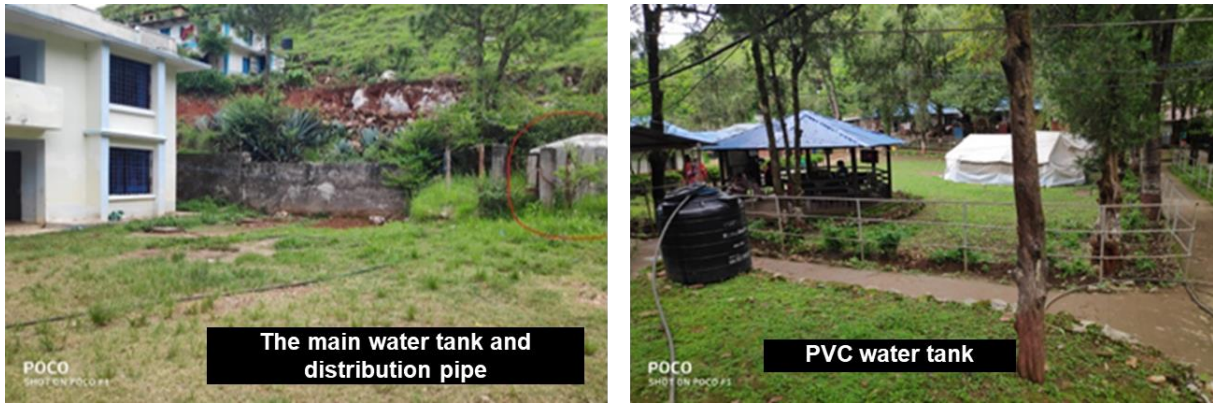
Figure 11: Water storage and distribution at the hospital

Water supply is one of the major issues in the Hospital. There is one small water tank of about 5,000 litres dating from 2045 B.S.(1988), and this capacity is wholly insufficient to serve the Hospital m(see Figure 11) The supply from the water source (spring water) is also irregular, which exacerbates the problem of inadequate storage. There is no provision for drinking water in the service areas for hospital visitors. There are some isolated PVC water tanks at different locations to store water. Overhead water tanks are also present on the roofs of the two-storied residential quarters.

- Construction of 100,000-liter underground water tank and 50,0000 litre overhead tank to ensure regular water supply service to the Hospital. This will also include wash facilities in service areas in compliance with the NHIDS, as well as installation of drinking water facilities at appropriate locations.

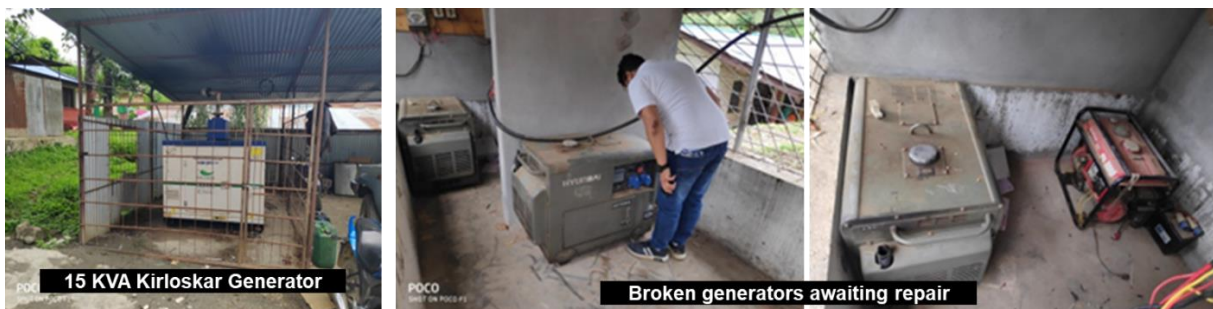
Figure 12: Generators at the hospital

There is an electrical supply from the city grid to the Hospital, but no dedicated transformer to ensuring a regular and consistent electrical supply. Consequently, voltage fluctuates which can have a negative impact on medical and electrical equipment and its performance. There is a Kirloskar brand generator with 15 KVA power capacity as a backup supply. There are three more generators (2 x 5.7 KVA, 1 x 2.1 KVA) outside the OT building, all are inoperable and awaiting repair (see Figure 12). There is no Uninterrupted Power Supply (UPS) in the OT in case of outage to cover the transfer time from the mains to the generator. Lights for the pathways and compounds are not sufficient and it needs to be installed in appropriate locations.

- Installation of firefighting equipment
- Repair of generators and provision of a dedicated backup system with UPS to the OT
- Initiate the process for the provision of dedicated transformer with uninterrupted supply to the Hospital

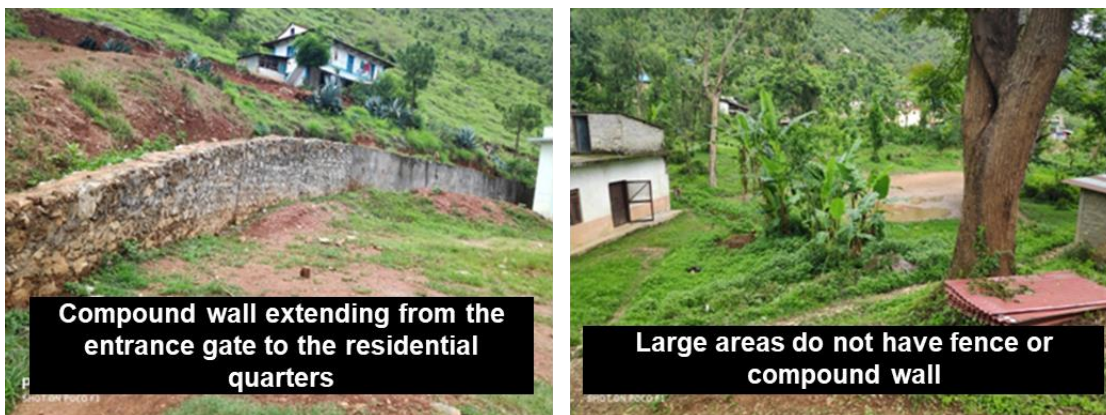
Figure 13: Inadequate boundary wall and fence

Except for a few meters near the entrance point, there is no compound wall in the hospital facility. Some areas are fenced with barbed wire, but this is patchy and falling apart.

Consequently, cattle frequently trespass into the precinct, and there is a security problem with frequent thefts from buildings (see Figure 13).

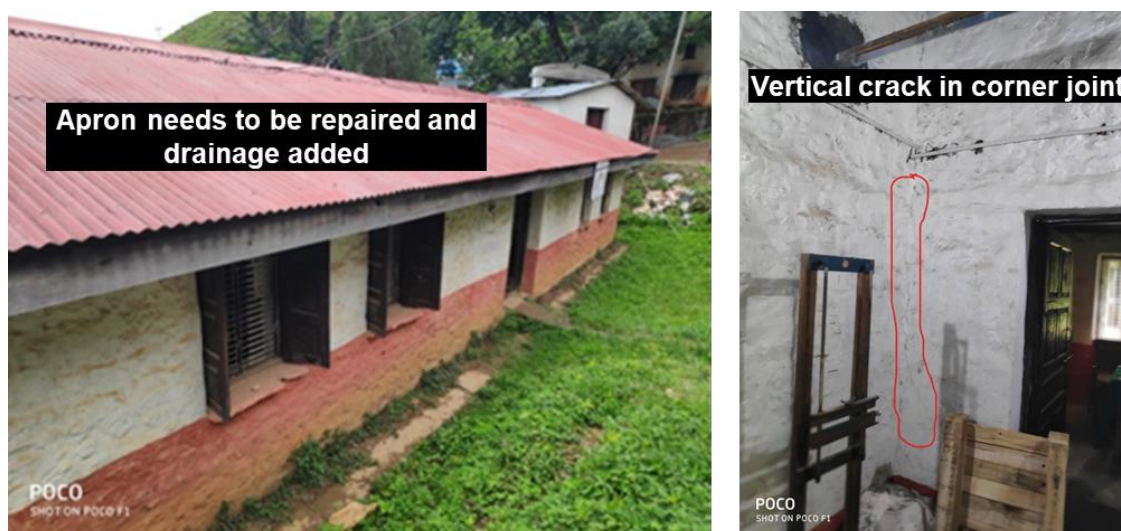
Figure 14: Defective aprons and corner cracks

Although the building blocks were recently renovated, there are numerous wall cracks and crack to corner joints. The buildings do not have seismic elements, such as cills or lintels, which makes them vulnerable to seismic shocks. The walls are thick (450 mm) in most cases, and so are well insulated against extreme temperatures.

The aprons around the buildings are damaged and there are no drainage channels (see Figure 14 and 15). Buildings also lack gutters and drainpipes. Mostly the buildings are surrounded by grass growing around them. The wards do not have heating systems for winter.

- Carry out renovations and space adjustment in the Maternity block.
- Conduct a detailed seismic assessment of all the building blocks including geotechnical investigations

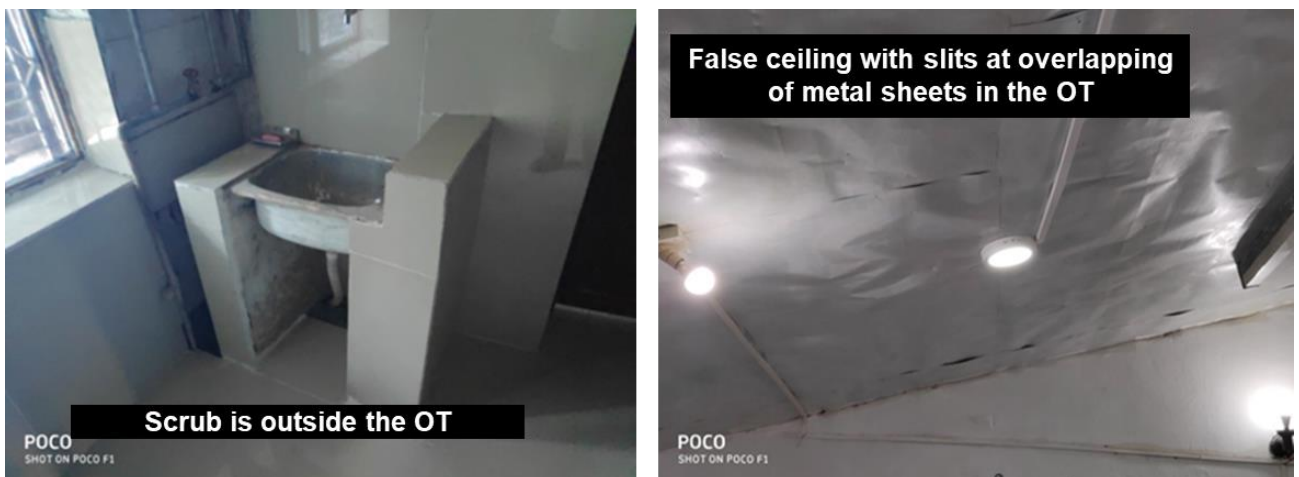
Figure 16: OT scrub and ceilings

In the OT area, the sanitary and electrical fittings are not appropriate, including the lighting fixtures. There is no proper scrub area. Lighting levels in the OT are not appropriate and the internal ceiling (false ceiling) is not suitable for OT. The ceilings have joints and openings vulnerable to dust accumulation and insects (see Figure 16 and 17). The wall paints are also not appropriate for OT.

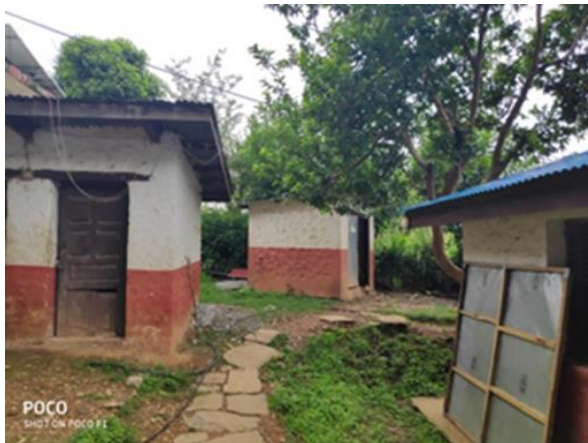
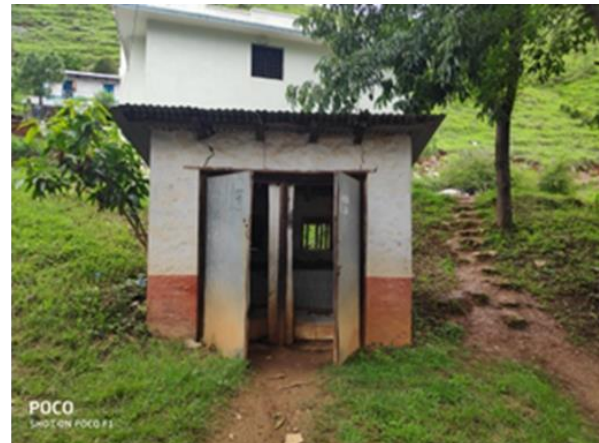
Figure 18: Toilet blocks

Most of the toilet blocks are in very poor condition and some are inoperable. They are scattered across the precinct, which makes it difficult to maintain and operate (see Figure 18).

- Construction of a toilet blocks with provision for people with disabilities, along with bathing and washing areas for patient and their attendants.
- Upgrading of the present Store block in the Hospital

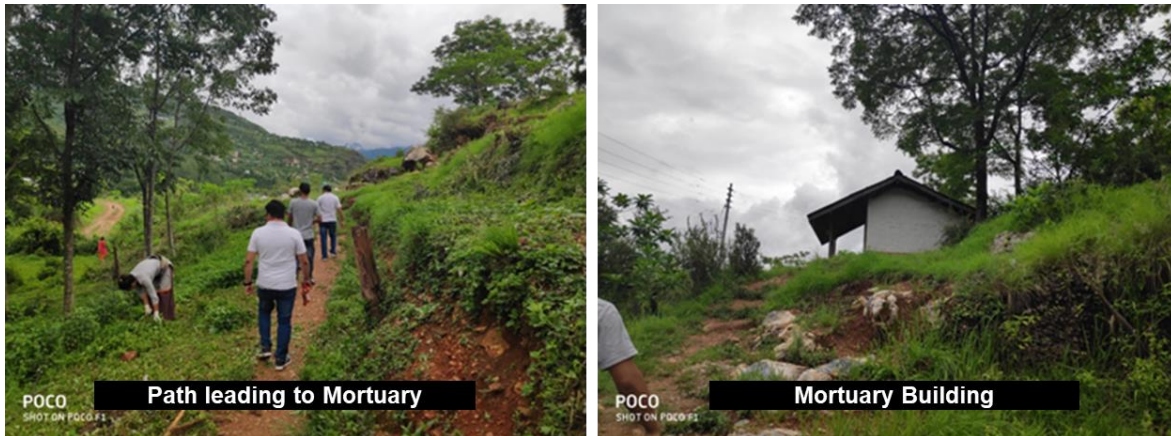
Figure 19: Mortuary

The existing Mortuary is absolutely sub-standard and probably dangerous. It is totally inadequate for carrying out postmortems or storing dead bodies (see Figure 19). On the field visit the NHSSP team were faced with the strong smell of a decaying cadaver.

- Replacement of all the wooden windows recently taken out of the facility.
- Construction of a standard postmortem building with appropriate freezers for cadaver storage.
